Aristida Homeowners Association, Inc
c/o Wise Property Management, Inc. / Joseph Vilardi, LCAM
18550 N. Dale Mabry Hwy.
Lutz, FL 33548

July 14, 2022

Re: **SWFWMD ERP – 2022 Stormwater System Permit Renewal Inspection Report**
SWFWMD Project Name: **Aristida - Phase 1** (111.9 acres)
Permit No. 40 002878.005 / Pasco County

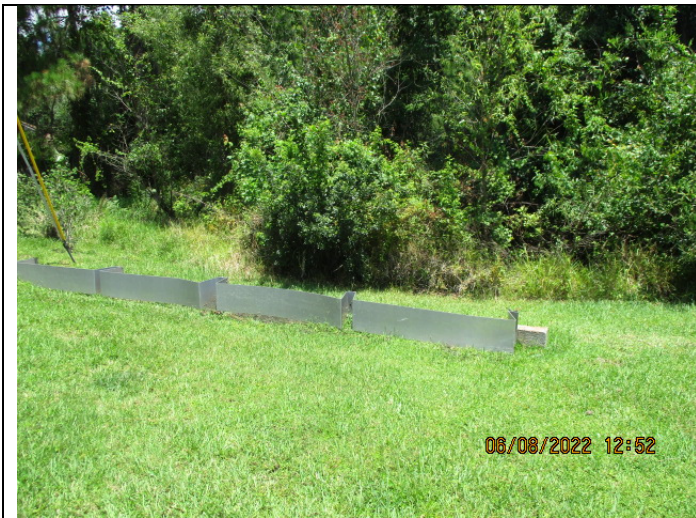
- There are concrete Weir Structures through out the permitted area within the swale and berm systems that receive run off from the road and discharge to the wetlands. Many have excessive vegetation around the structures and inside the skimmers. Some are completely overgrown and others could not be located as indicated by the plans. We recommend clearing the vegetation so any other required maintenance, such as removing silt build up under the skimmers and/or on the discharge sides, can be conducted, as necessary, Some areas may also require some minor excavation or re-trenching to ensure proper flow into the wetlands. The berms may also need some attention. (See image #1 thru 8 and Site Plans).

Image 1: Concrete Weir & Skimmer example

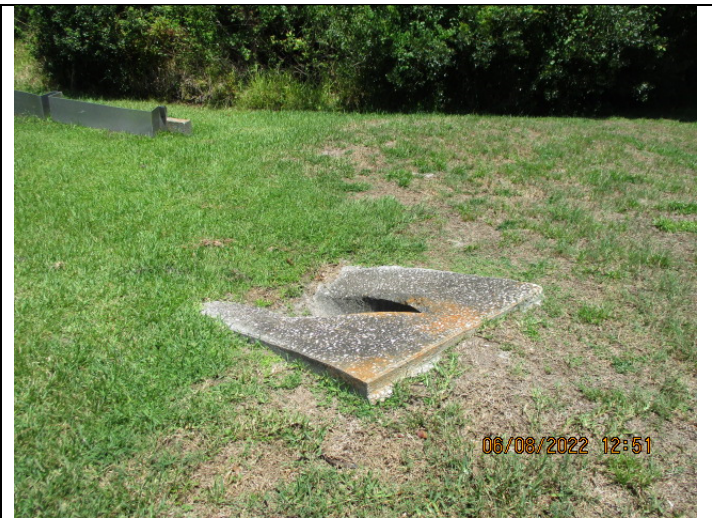
Image 2: MES/Pipe discharges towards Weir, swale may need minor exaction

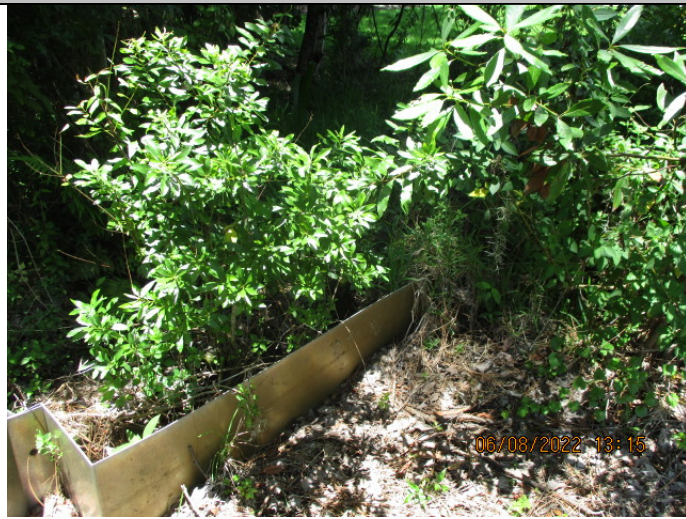
Image 3: Weir, Skimmer, needs clearing

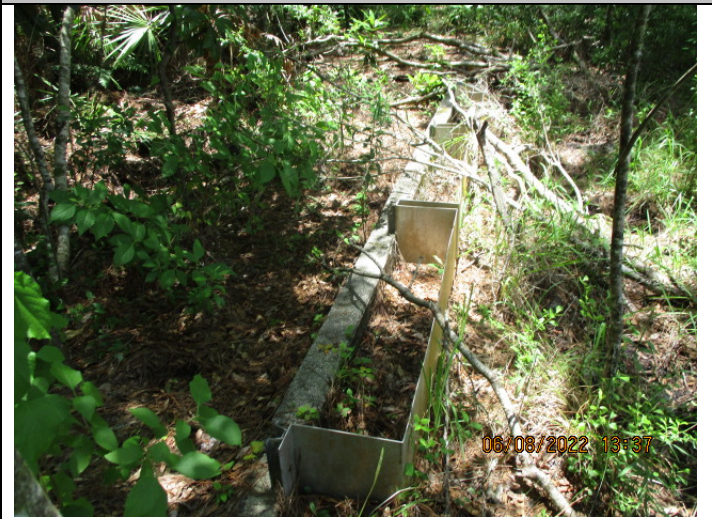
Image 4: Weir, skimmer need clearing, both sides

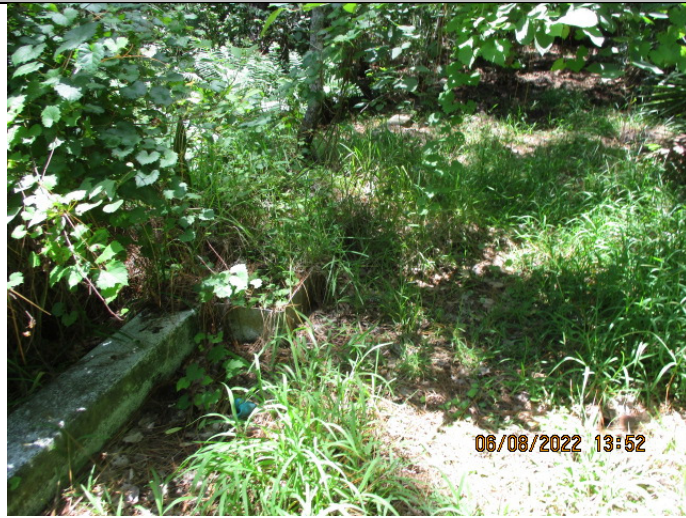
Image 5: Weir, Skimmer need clearing, both sides

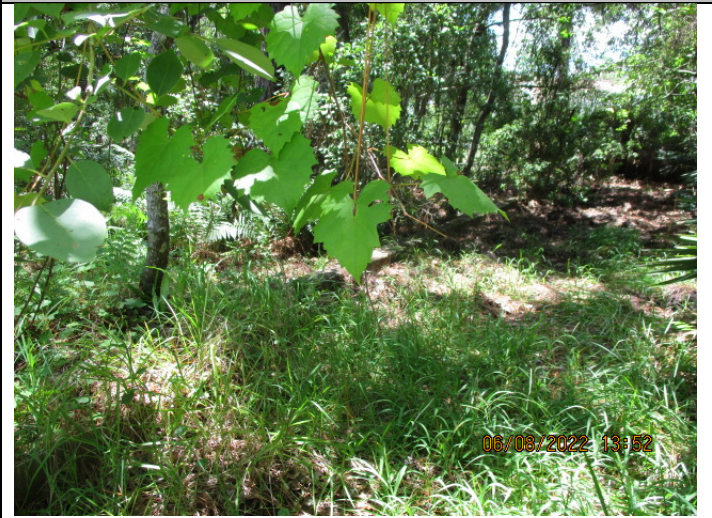
Image 6: Weir, Skimmer barely visible, needs clearing both sides

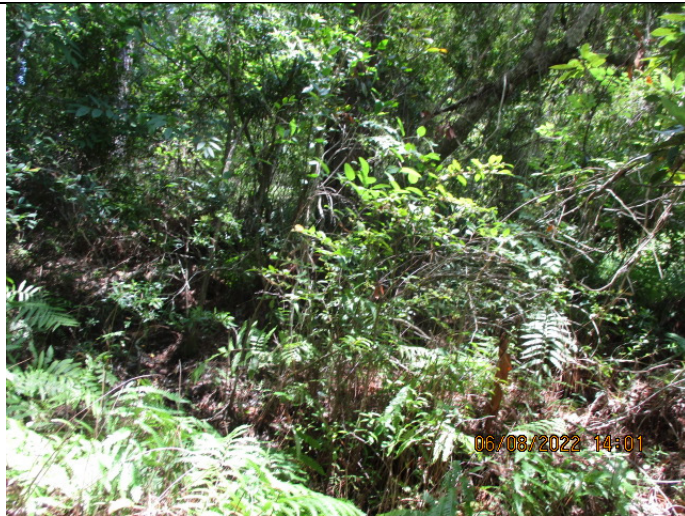
Image 7: Weir, Skimmer area, unable to locate

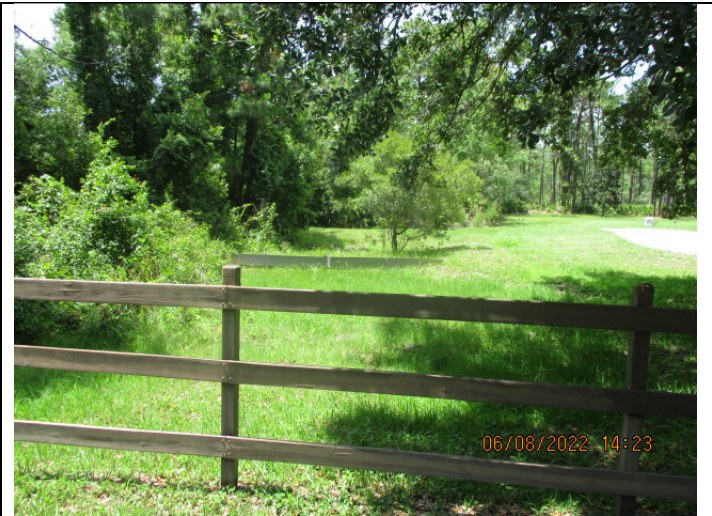
Image 8: Weir, Skimmer, needs minor clearing

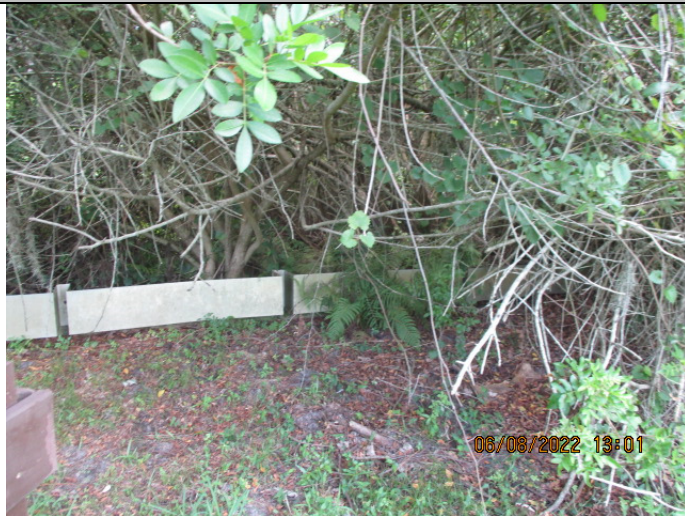
- There are also concrete Weir Structures in the swale and berm systems at the wetlands behind the homes that receive run off from the residential lots. Some of these also have excessive vegetation around the structures and inside the skimmers. Some are overgrown and others could not be located as indicated by the plans. We recommend clearing the vegetation so any other required maintenance, such as removing silt build up under the skimmers and on the discharge sides, can be conducted, as necessary. Some areas may also require some minor excavation to ensure proper flow into the wetlands. Please note, some rear yards were not accessible to inspect the weirs. (See image #9 thru 12 and Site Plans).

Image 9: Weir, Skimmer (rear yard) needs clearing

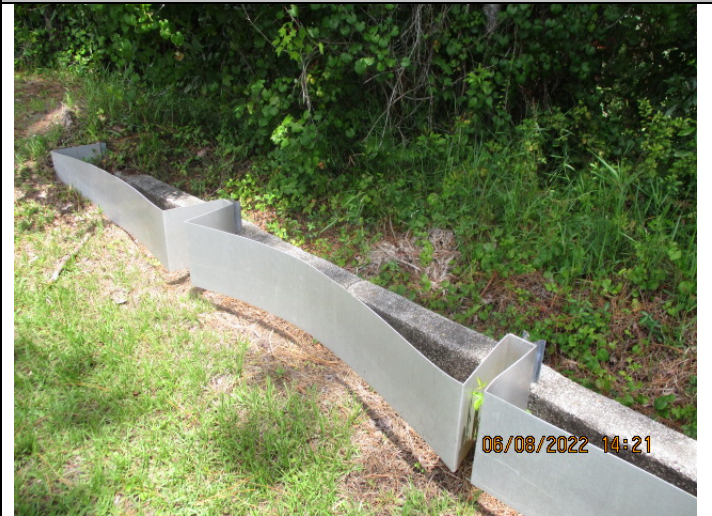
Image 10: Weir, Skimmer (rear yard) needs some clearing behind structure

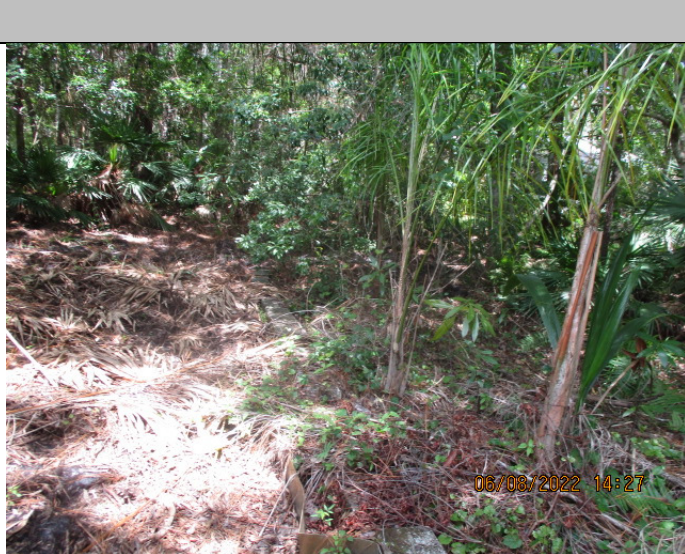
Image 11: Weir, Skimmer (rear yard) Barely Visible

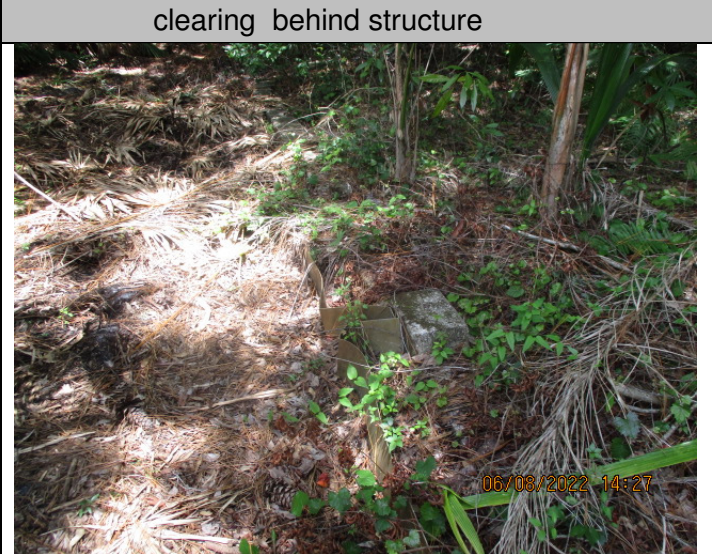
Image 12: Weir, Skimmer (rear yard) Barely Visible

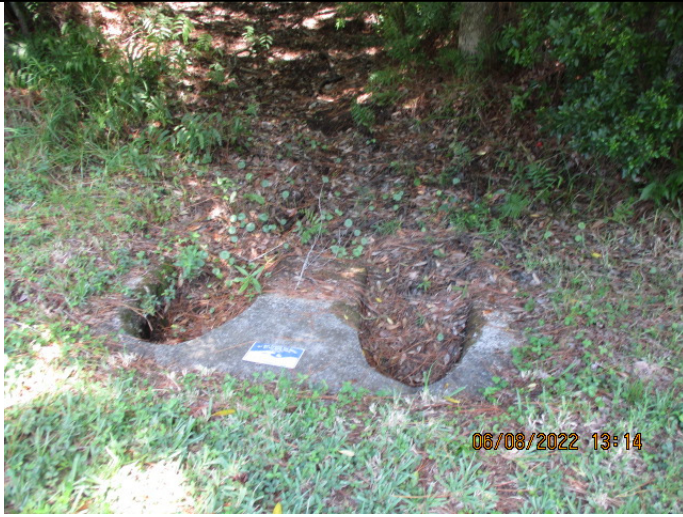
- The Mitered End Section (MES)/Pipe system that flows under Alico Pass (just north of Macoso CT) and connects the wetlands has silt build up, debris and vegetation in pipe ends that should be cleared. (See images #13)

Image 13: MES/Pipes, silt build up, debris, needs clearing

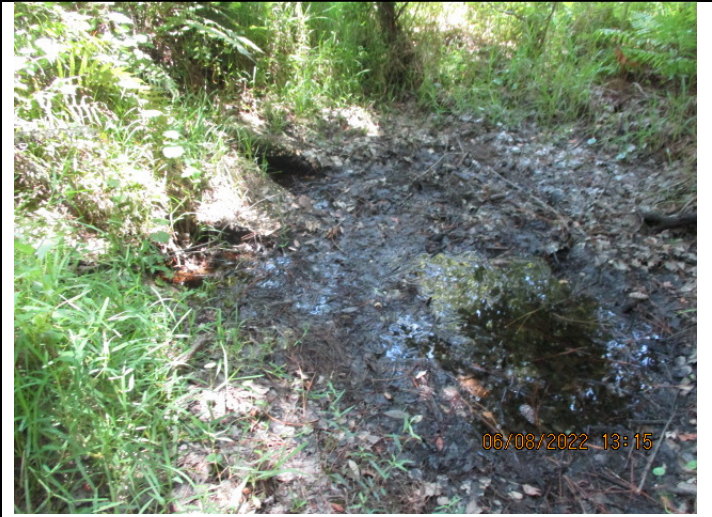
- The connecting MES/Pipe system on the opposite side of the road has silt build up and muck in the pipe ends that should be cleared. The sump area there has a build up of muck that should be removed. (See image #14)

Image 14: MES/Pipes, silt build up, muck, needs Clearing, muck removal

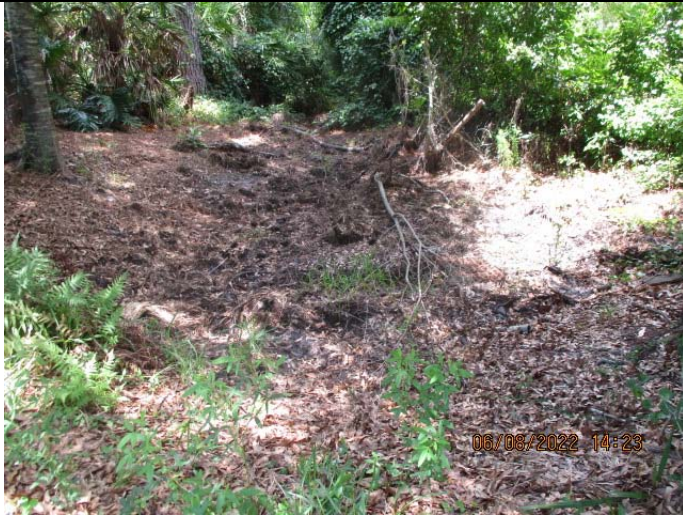
- There is a large Type H inlet basin on the north side of the road (Alico Pass) that receives flow from the mitigation area. The top grate is covered with debris and muck that should be cleared. The grates should be lifted and the basin cleared, if necessary. (See image #15)

Image 15: Inlet basin/ Grate completely covered with silt, debris, needs clearing

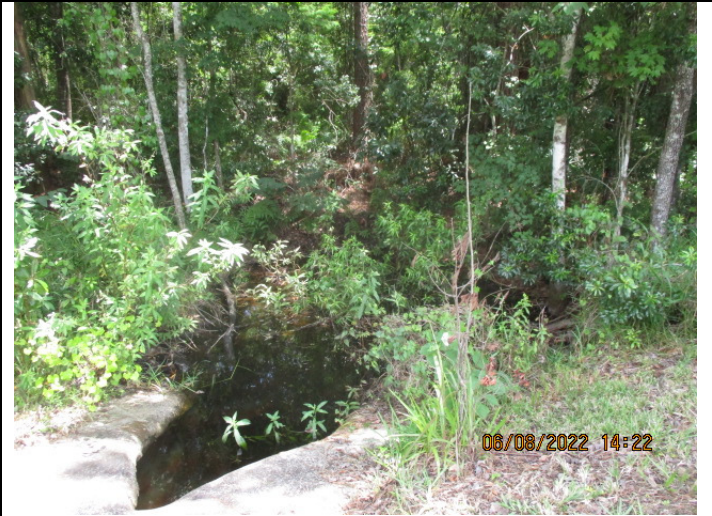
- The HOA may want to consider some clearing at the discharge area of the connecting MES/Pipe on the opposite side of the road (See image #16)
- The MES/Pipe that receives flow from the ditch bottom inlet basin on the north side of Alico and discharges on the south side (near the entrance) has some silt build up and vegetation in pipe end and at the discharge area that should be cleared. The sump area there may also require some excavation. (See images #17 & 18)

Image 16: Weir Structure, Skimmer west swale, needs clearing

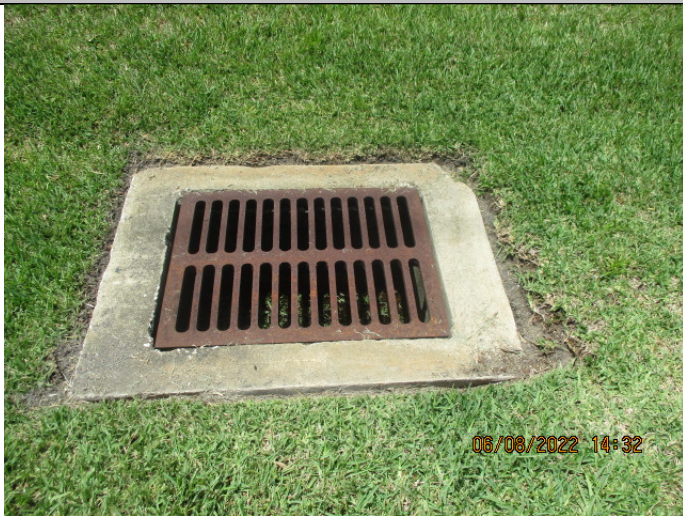
Image 17: Pipe in connector system under rod

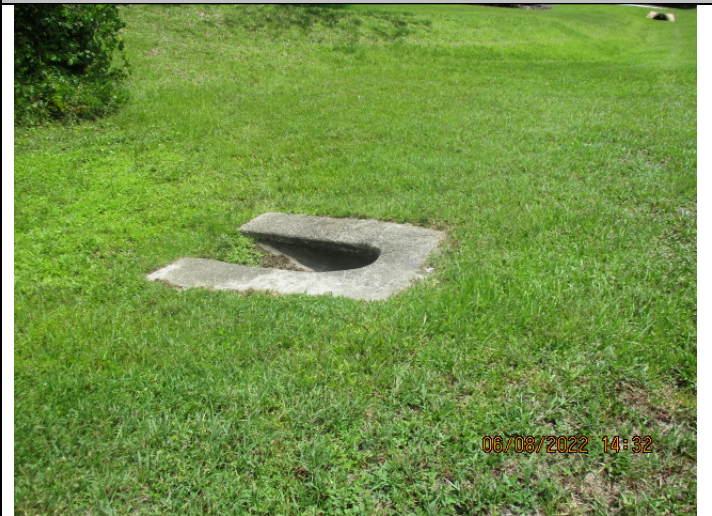
Image 18: MES/Discharge, Feral hog damage
