July 12, 2022

Re: **SWFWMD ERP – 2022 Stormwater System Permit Renewal Inspection Report**  
SWFWMD Project Name: **Aristida - Phase 2** (47.05 acres)  
Permit No. 40 002878.008 / Pasco County

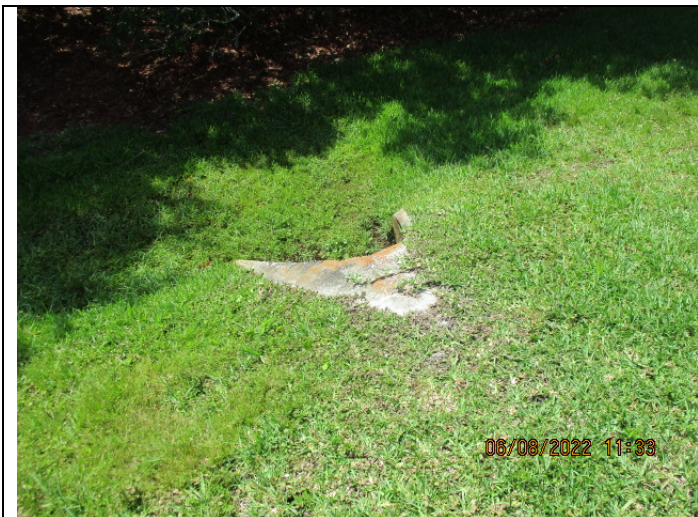
- The Flared End Section (FES)/Pipe ends of the pipes that convey water from the roadside swales and connect to the swales that then flow to the wetlands, have excessive silt build up and vegetation in pipe ends and at the discharge or inlet areas. We recommend clearing the pipe ends and discharge areas. (See images #1, 2, 3 & 8)

- The roadside swales also have some silt build up and vegetation that has accumulated in the swales and around some of the pipe ends and/or other structures, but it's not as bad as swales that flow off the road to the wetland. It appears the homeowners or others are taking care of most of these. However, some areas may still need some attention (See images #1, 6, & 7)

Image 1: FES/Pipe inlet connects road swale to swale that discharges to wetland

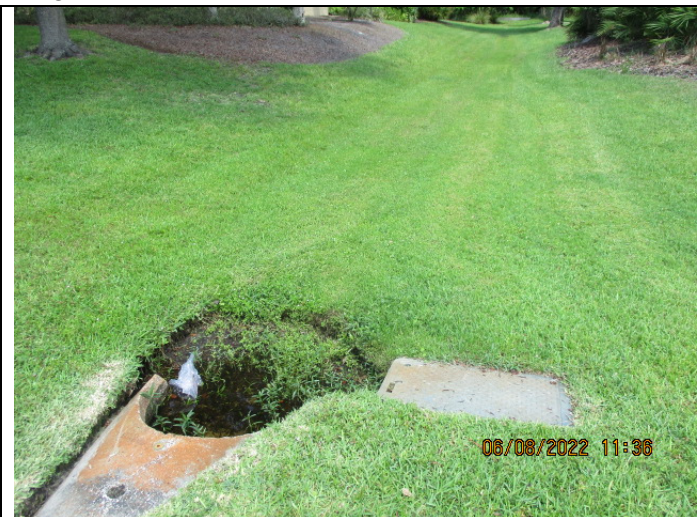
- The swales that flow to the wetland have a build up of silt and vegetation that has accumulated over the years. The swales should be excavated, re-cut and/or graded to enable proper flow. (See images #2 & 3 and 8, 9, and 10)

Image 2: FES/Pipe discharges to wetland via swale excessive silt & vegetation build up at pipe end.

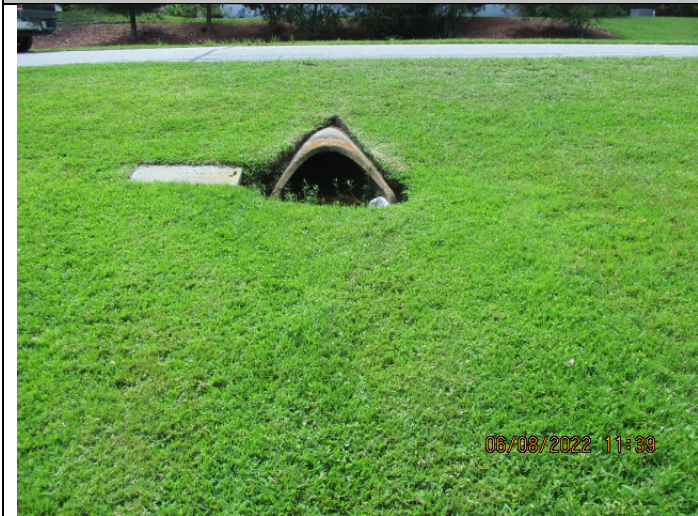
Image 3: Opposite view, swale filled in should be to bottom of pipe

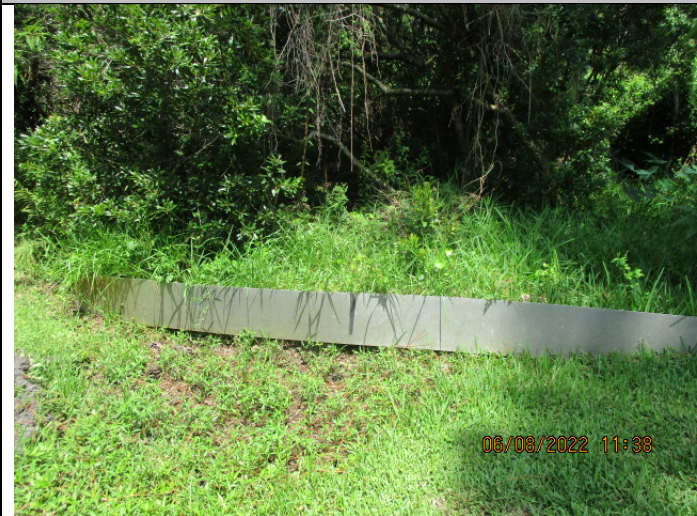
- The concrete Weir Structures located at the end of the swales that discharge to the wetland have vegetation and overgrowth around the structures and inside the Skimmers that should be removed/cleared. Any silt build up under the skimmer should be removed to allow for a 4" to 6" gap. (See images #4 & 5 and 10)

Image 4: Weir Structure & Skimmer at end of swale, discharges to wetland, needs clearing,

- Once the overgrowth on the discharge side of the Weir Structures is removed/cleared, they will likely require some excavation or re-trenching to ensure proper flow into the wetlands. (See images #4 & 5 and 10)

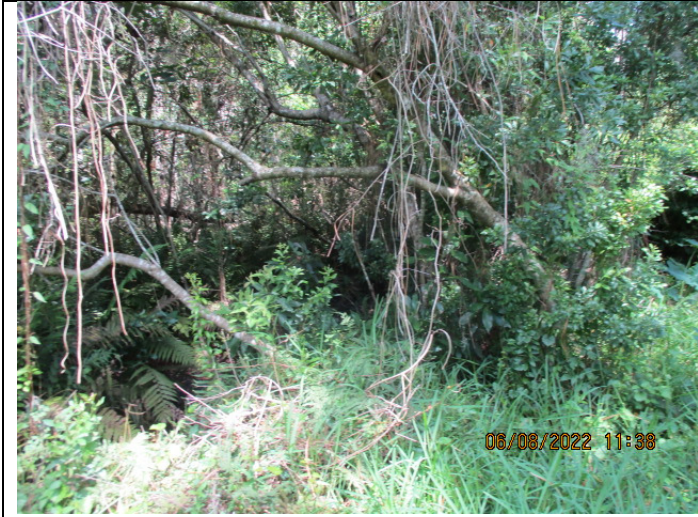
Image 5: Discharge side of weir, needs clearing, possibly re-trenching

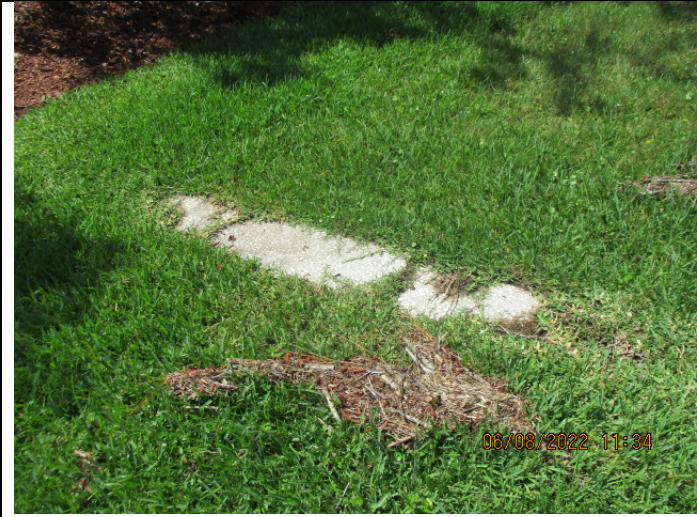
Image 6: Ditch check (weir) silt build up & Vegetation in roadside swale

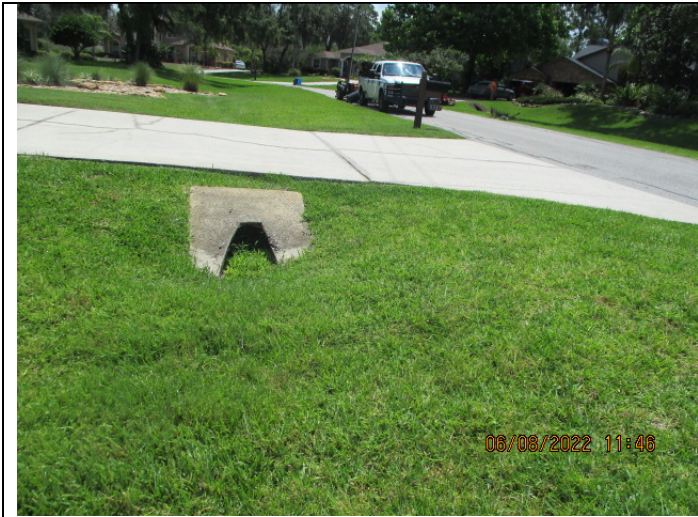
Image 7: MES/Pipe, silt build and vegetation in Roadside swale

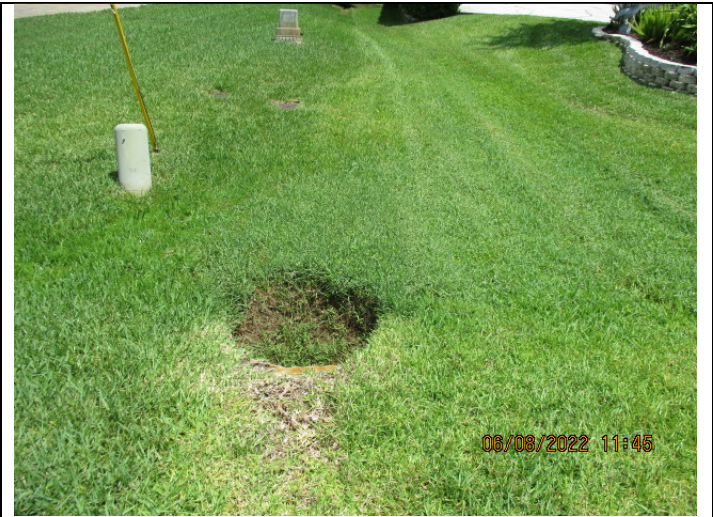
Image 8: FES/Pipe in swale that flows to wetland excessive silt & vegetation build up at pipe end

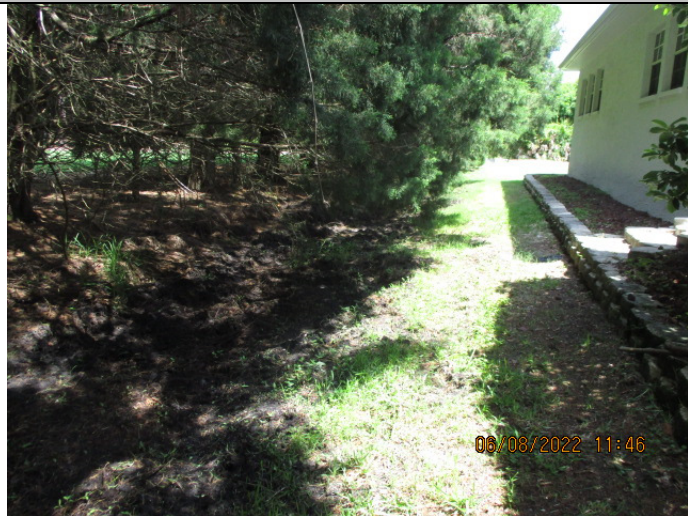
- At the time of our inspection there were some lawn areas that appeared to be damaged by feral hogs. One resident (5337 Haltata) complained about this to me while I was on site. She said they were getting through the fence of the adjoining conservation land that is under SWFWMD jurisdiction. She also mentioned that Michael May who is a board member was addressing the matter .(See images #9 & 18)

Image 9: Center area of swale,

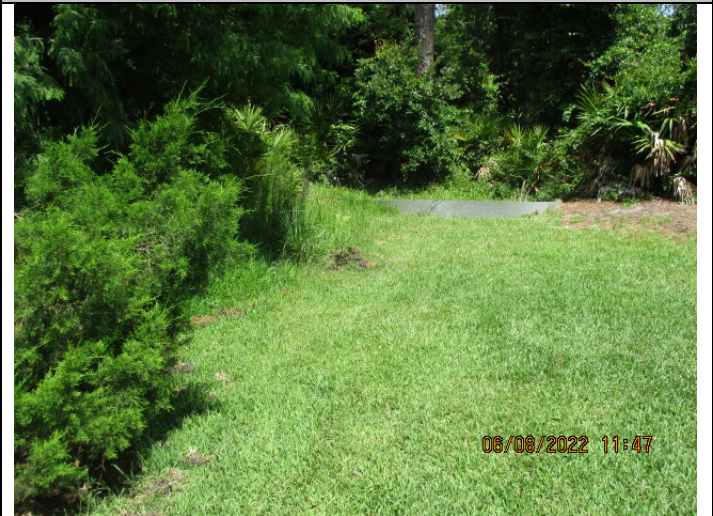
Image 10: Weir Structure at wetland discharge area

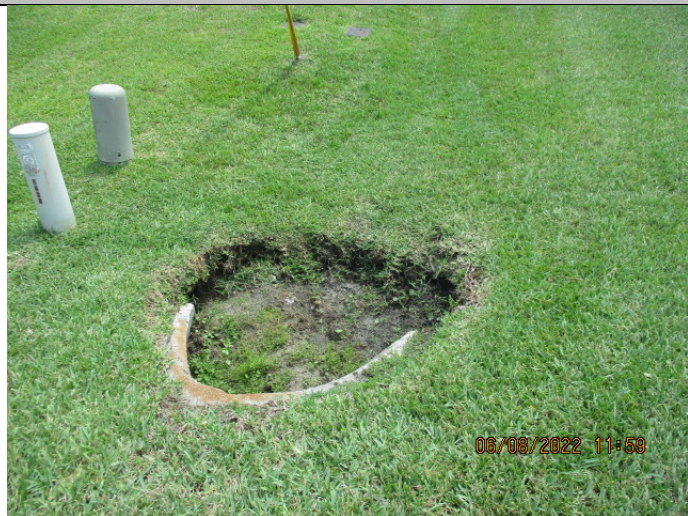
- The FES/Pipe end and inlet area of the pipe that receives flow from the swale that collects water from east boundary and flows under the road to the wetland to the west has excessive silt build up and vegetation that should be cleared. (See images #11)

Image 11: FES/Pipe inlet collects water from east boundary flows under road

- That swale also has some build up of silt and vegetation that has accumulated over the years. The HOA may want to consider some excavation, re-cutting and/or grading of this swale to enable proper flow. (See image #11)

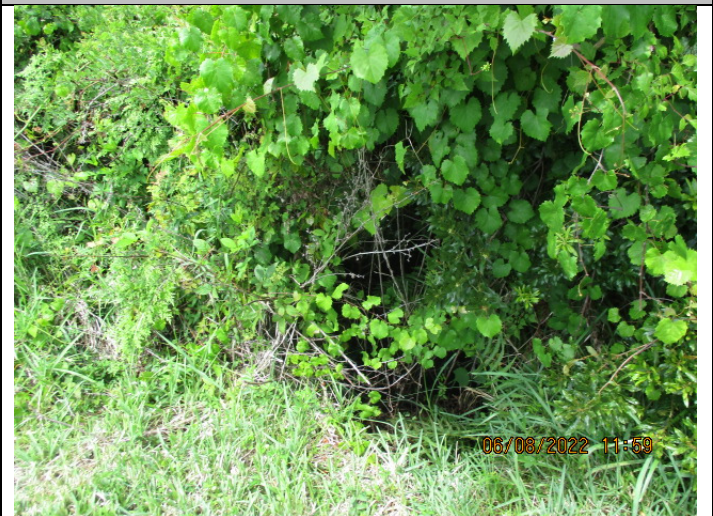
- The connecting pipe on the opposite side of the road has excessive overgrowth and is barely visible. It should be cleared and inspected. The swale that flows from the pipe end into the wetland will probably need to be re-trenched. (See image #12)

Image 12: Connecting Fes/Pipe on opposite side of road barely visible, needs clearing

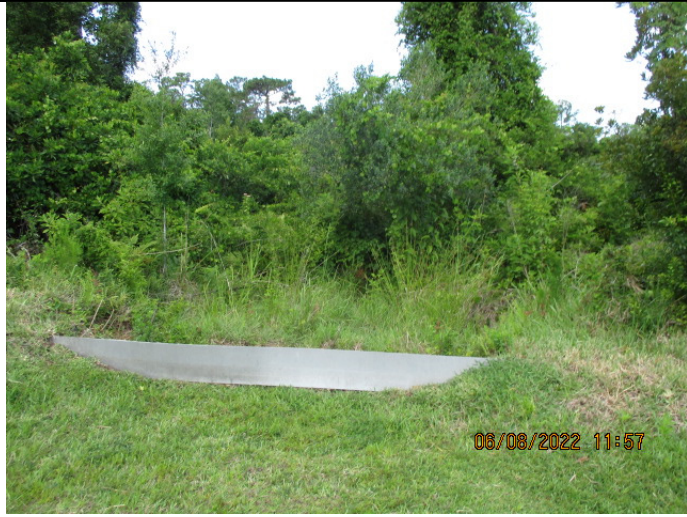
- There are concrete Weir Structures that receive run off from the road and discharge to the wetlands that have excessive vegetation around the structures and inside the skimmers (near the end of Haltata) that should be cleared. One is completely overgrown. Any silt build up under the skimmers should be removed. These may also require some re-trenching to ensure proper flow into the wetlands. (See image #13)

Image 13: Weir, Skimmer road run off, need clearing

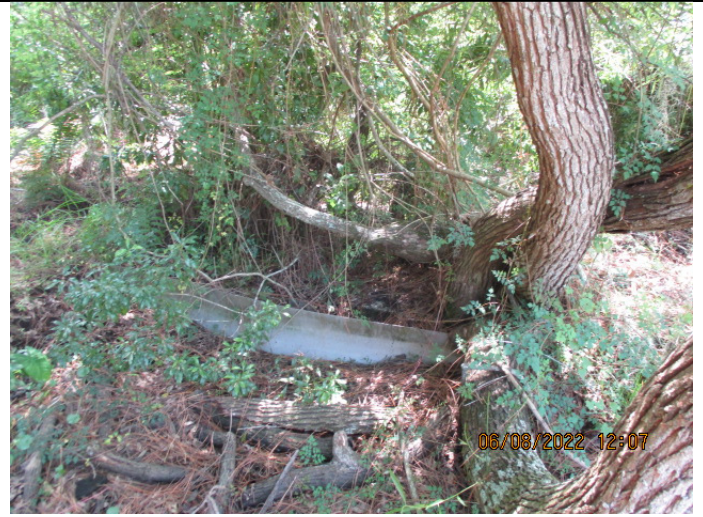
- There are concrete Weir Structures in the swale on the east side of the permitted area (behind the homes) that discharge to the wetland that have excessive vegetation around the structures and inside the skimmers that should be cleared. Any silt build up under the skimmers should be removed. They may also require some re-trenching to ensure proper flow into the wetlands. (See image #14 & 15)

Image 14: Weir Structure, Skimmer east swale, needs clearing

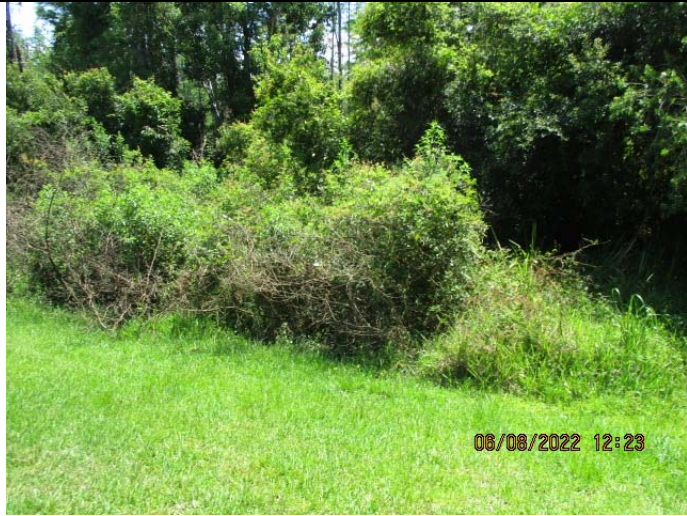
Image 15: Weir Structure, Skimmer east swale, completely overgrown, needs clearing

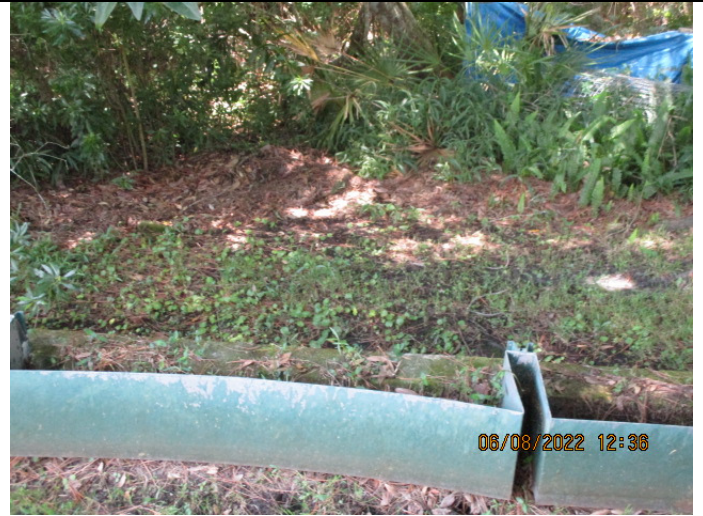
- There are also concrete Weir structures in the swale on the west side of the permitted area (behind the homes on Alico Pass) that discharge to the wetland that have excessive vegetation around the structures and inside the skimmers that should be cleared. Any silt build up under the skimmer should be removed. They may also require some re-trenching to ensure proper flow into the wetlands. (See images #16)

Image 16: Weir Structure, Skimmer west swale, needs clearing

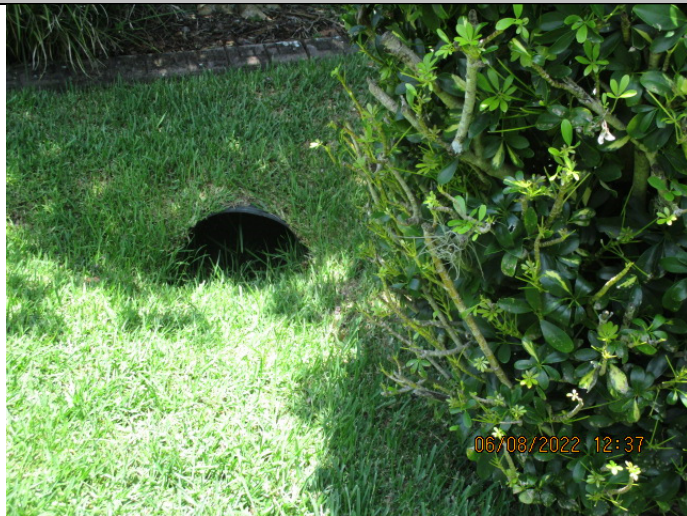
- Some of the pipe ends in the connector piping systems on the west side of the permitted area (on Alico Pass) have silt build up and may need some minor clearing (See image #17)

Image 17: Pipe in connector system under rod

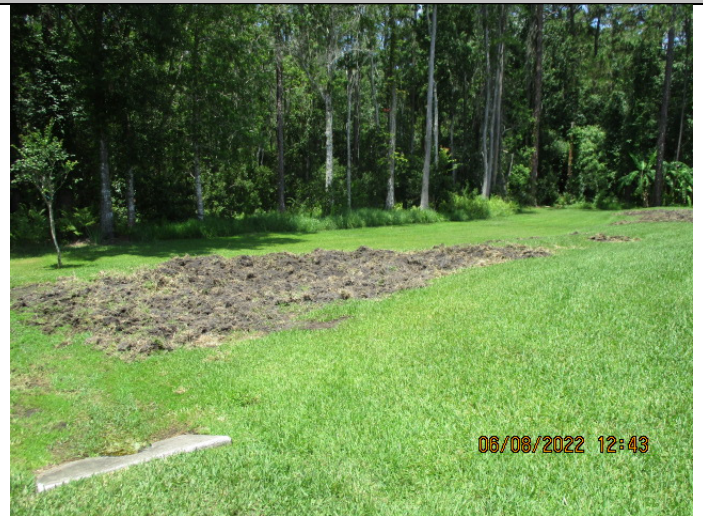
Image 18: MES/Discharge, Feral hog damage
