Re: SWFWMD ERP – 2022 Stormwater System Permit Renewal Inspection Report

SWFWMD Project Name: **Aristida - Phase 3** (111.9 acres) Permit No. 40 002878.009 / Pasco County

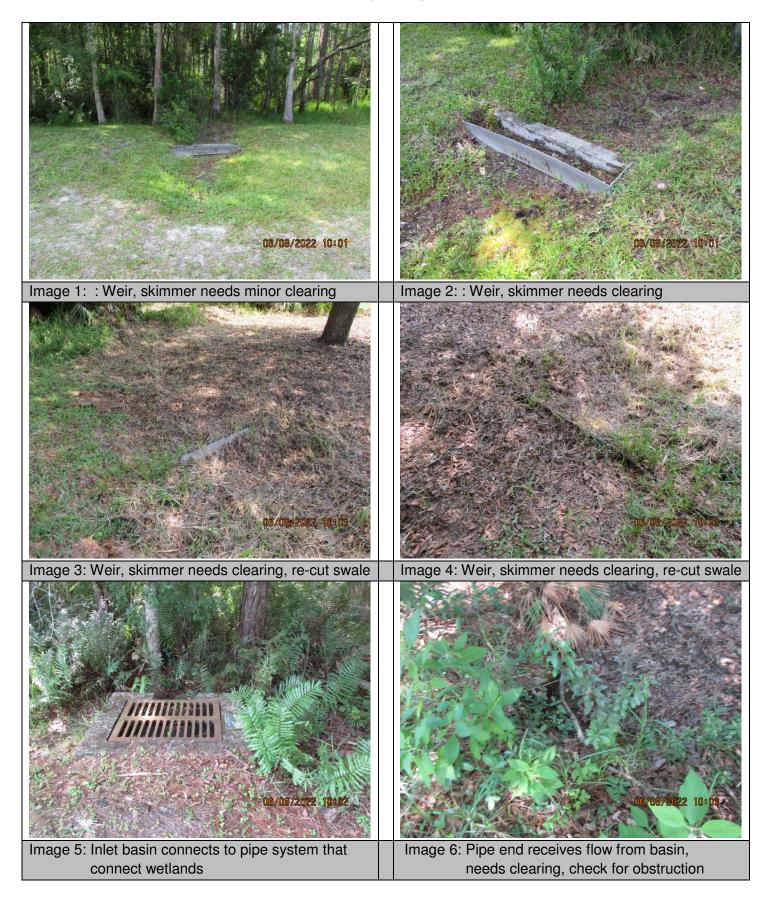
- There are Concrete and/or Geoweb Weir Structures throughout the permitted area in swales that receive run off from the road and discharge to the wetlands. Many have excessive vegetation and silt build up around the structures and inside the skimmers. We recommend clearing the vegetation and removing silt build up under the skimmers, as necessary. Some areas may also require some minor excavation or re-trenching on both the inlet and discharge sides to ensure proper flow into the wetlands. (See example images #1 thru 4).

- The Mitered End Section (MES) pipe end of the Pipe system that receives flow from the Basin structure (with grate) and flows under Alico Pass to connect the wetlands has silt build up, debris and vegetation in pipe that should be cleared. The Basin structure should also be cleared on the inlet side. (See images #5 &6)

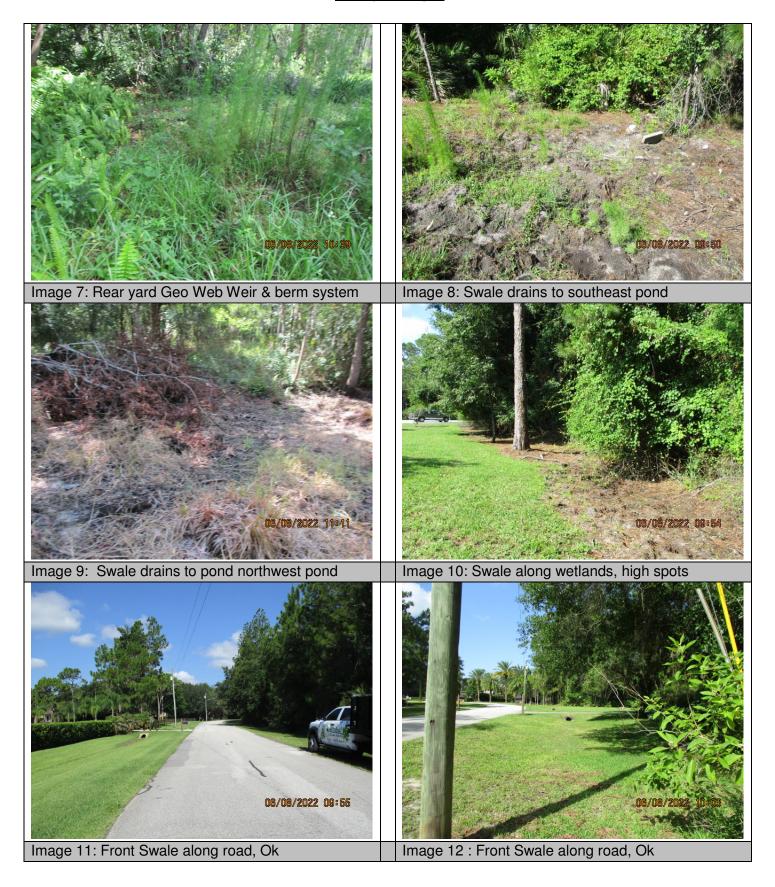
- There is rear yard berm systems behind the homes with intermittent swales with a Geoweb base that enables run off from the residential lots to flow to the wetlands. Some of these have vegetation and silt build up and may not be recognizable by the homeowners. We were very limited in the number of rear yards we were able to access and inspect in this permitted area. Some homeowners may not be aware of these as a part of the stormater system. We recommend clearing as needed. Some areas may also require some minor excavation or berm maintenance to ensure proper flow into the wetlands. (See image #7 and Site Plans).

- Some of the swales that flow to the ponds and/or wetland have a build up of silt and vegetation that has accumulated over the years. At some point the HOA may want to conduct some maintenance of the swales that need to be excavated, re-cut and/or graded to enable proper flow. (See example images #8, 9 & 10)

- The swales that rum along the roads in front of the lots appear to be well maintained except in few areas, mainly the lots that are not developed. (See example images #11 & 12)
- The available as-built plans used for the inspection are not very detailed and/or do not appear to be complete. There are a number of concrete or Geoweb weir structure that receive run-off from the road and flow to wetlands that were observed but are not depicted in the plans.
