Aristida Homeowners Association, Inc
c/o Wise Property Management, Inc. / Joseph Vilardi, LCAM
18550 N. Dale Mabry Hwy.
Lutz, FL 33548

July 14, 2022

Re: **SWFWMD ERP – 2022 Stormwater System Permit Renewal Inspection Report**
SWFWMD Project Name: **Aristida - Phase 1** (111.9 acres)
Permit No. 40 002878.005 / Pasco County

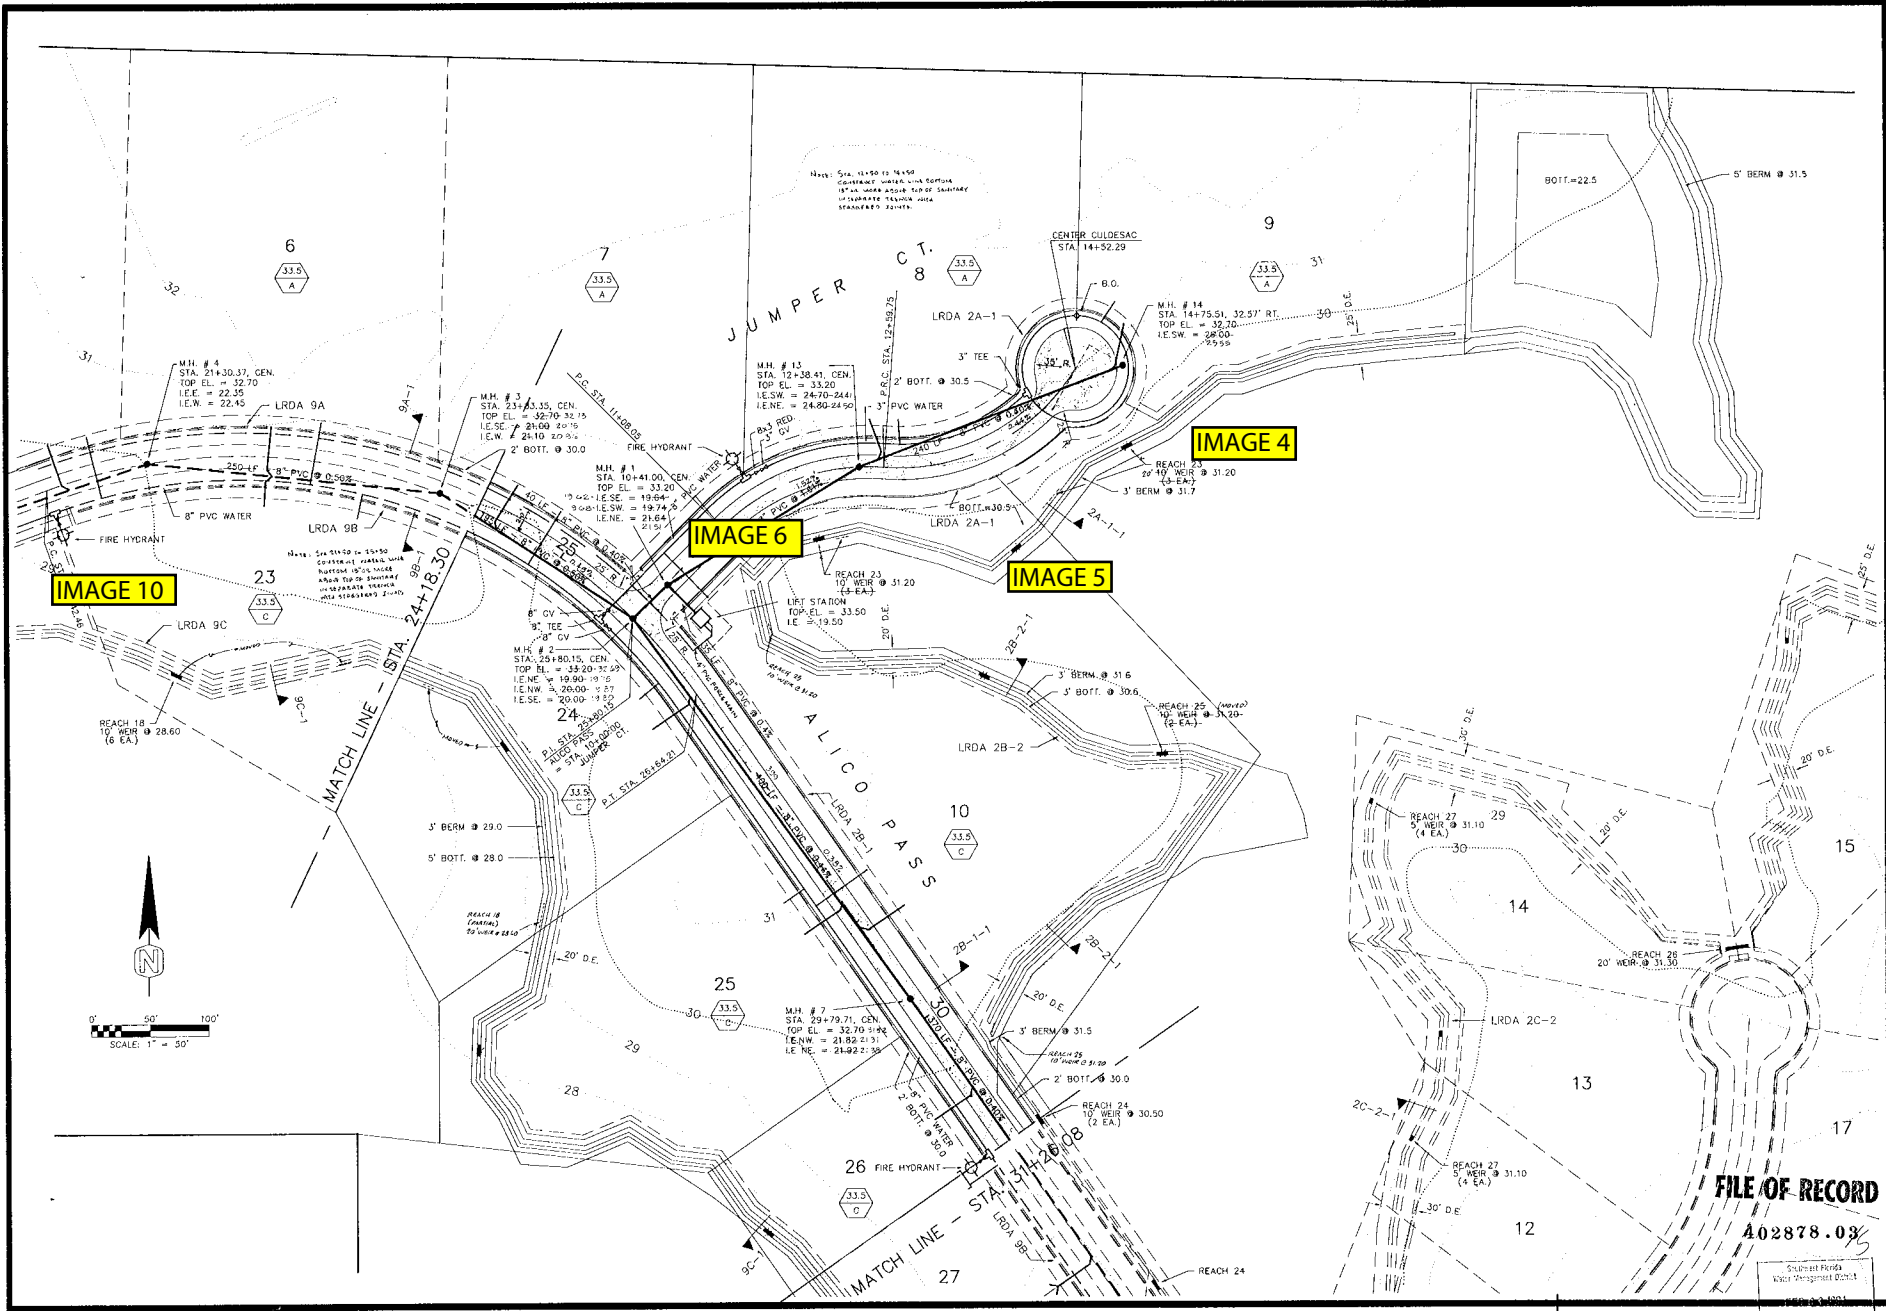
- There are concrete Weir Structures through out the permitted area within the swale and berm systems that receive run off from the road and discharge to the wetlands. Many have excessive vegetation around the structures and inside the skimmers. Some are completely overgrown and others could not be located as indicated by the plans. We recommend clearing the vegetation so any other required maintenance, such as removing silt build up under the skimmers and/or on the discharge sides, can be conducted, as necessary, Some areas may also require some minor excavation or re-trenching to ensure proper flow into the wetlands. The berms may also need some attention. (See image #1 thru 8 and Site Plans).

- There are also concrete Weir Structures in the swale and berm systems at the wetlands behind the homes that receive run off from the residential lots. Some of these also have excessive vegetation around the structures and inside the skimmers. Some are overgrown and others could not be located as indicated by the plans. We recommend clearing the vegetation so any other required maintenance, such as removing silt build up under the skimmers and on the discharge sides, can be conducted, as necessary. Some areas may also require some minor excavation to ensure proper flow into the wetlands. Please note, some rear yards were not accessible to inspect the weirs. (See image #9 thru 12 and Site Plans).

IMAGE 10

IMAGE 6

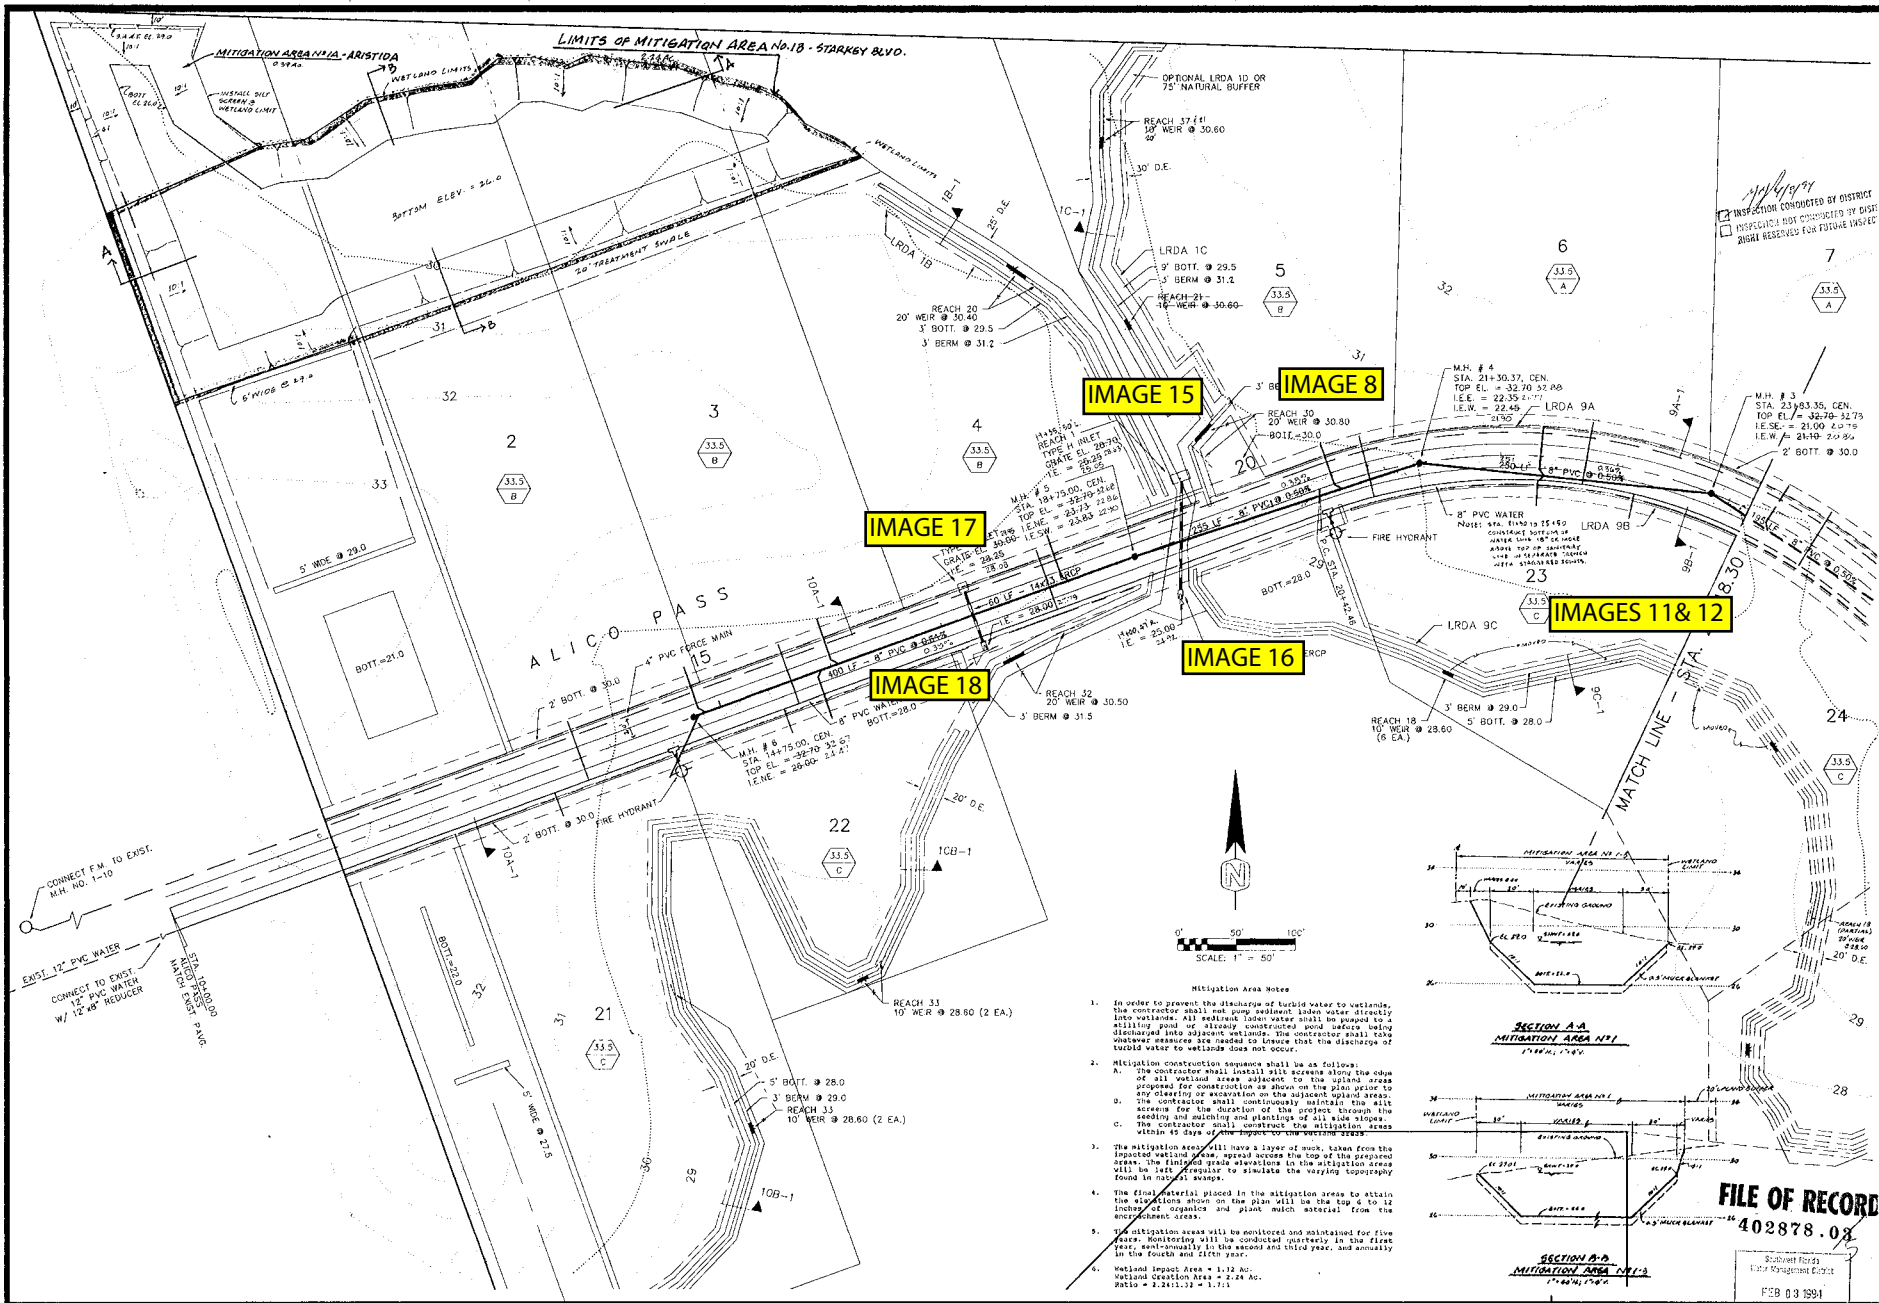
- There is a large Type H inlet basin on the north side of the road (Alico Pass) that receives flow from the mitigation area. The top grate is covered with debris and muck that should be cleared. The grates should be lifted and the basin cleared, if necessary. (See image #15)

- The HOA may want to consider some clearing at the discharge area of the connecting MES/Pipe on the opposite side of the road (See image #16)
- The MES/Pipe that receives flow from the ditch bottom inlet basin on the north side of Alico and discharges on the south side (near the entrance) has some silt build up and vegetation in pipe end and at the discharge area that should be cleared. The sump area there may also require some excavation. (See images #17 & 18)

IMAGE 15

IMAGE 8

IMAGE 18
