July 12, 2022

Re: **SWFWMD ERP – 2022 Stormwater System Permit Renewal Inspection Report**  
SWFWMD Project Name: **Aristida - Phase 2** (47.05 acres)  
Permit No. 40 002878.008 / Pasco County

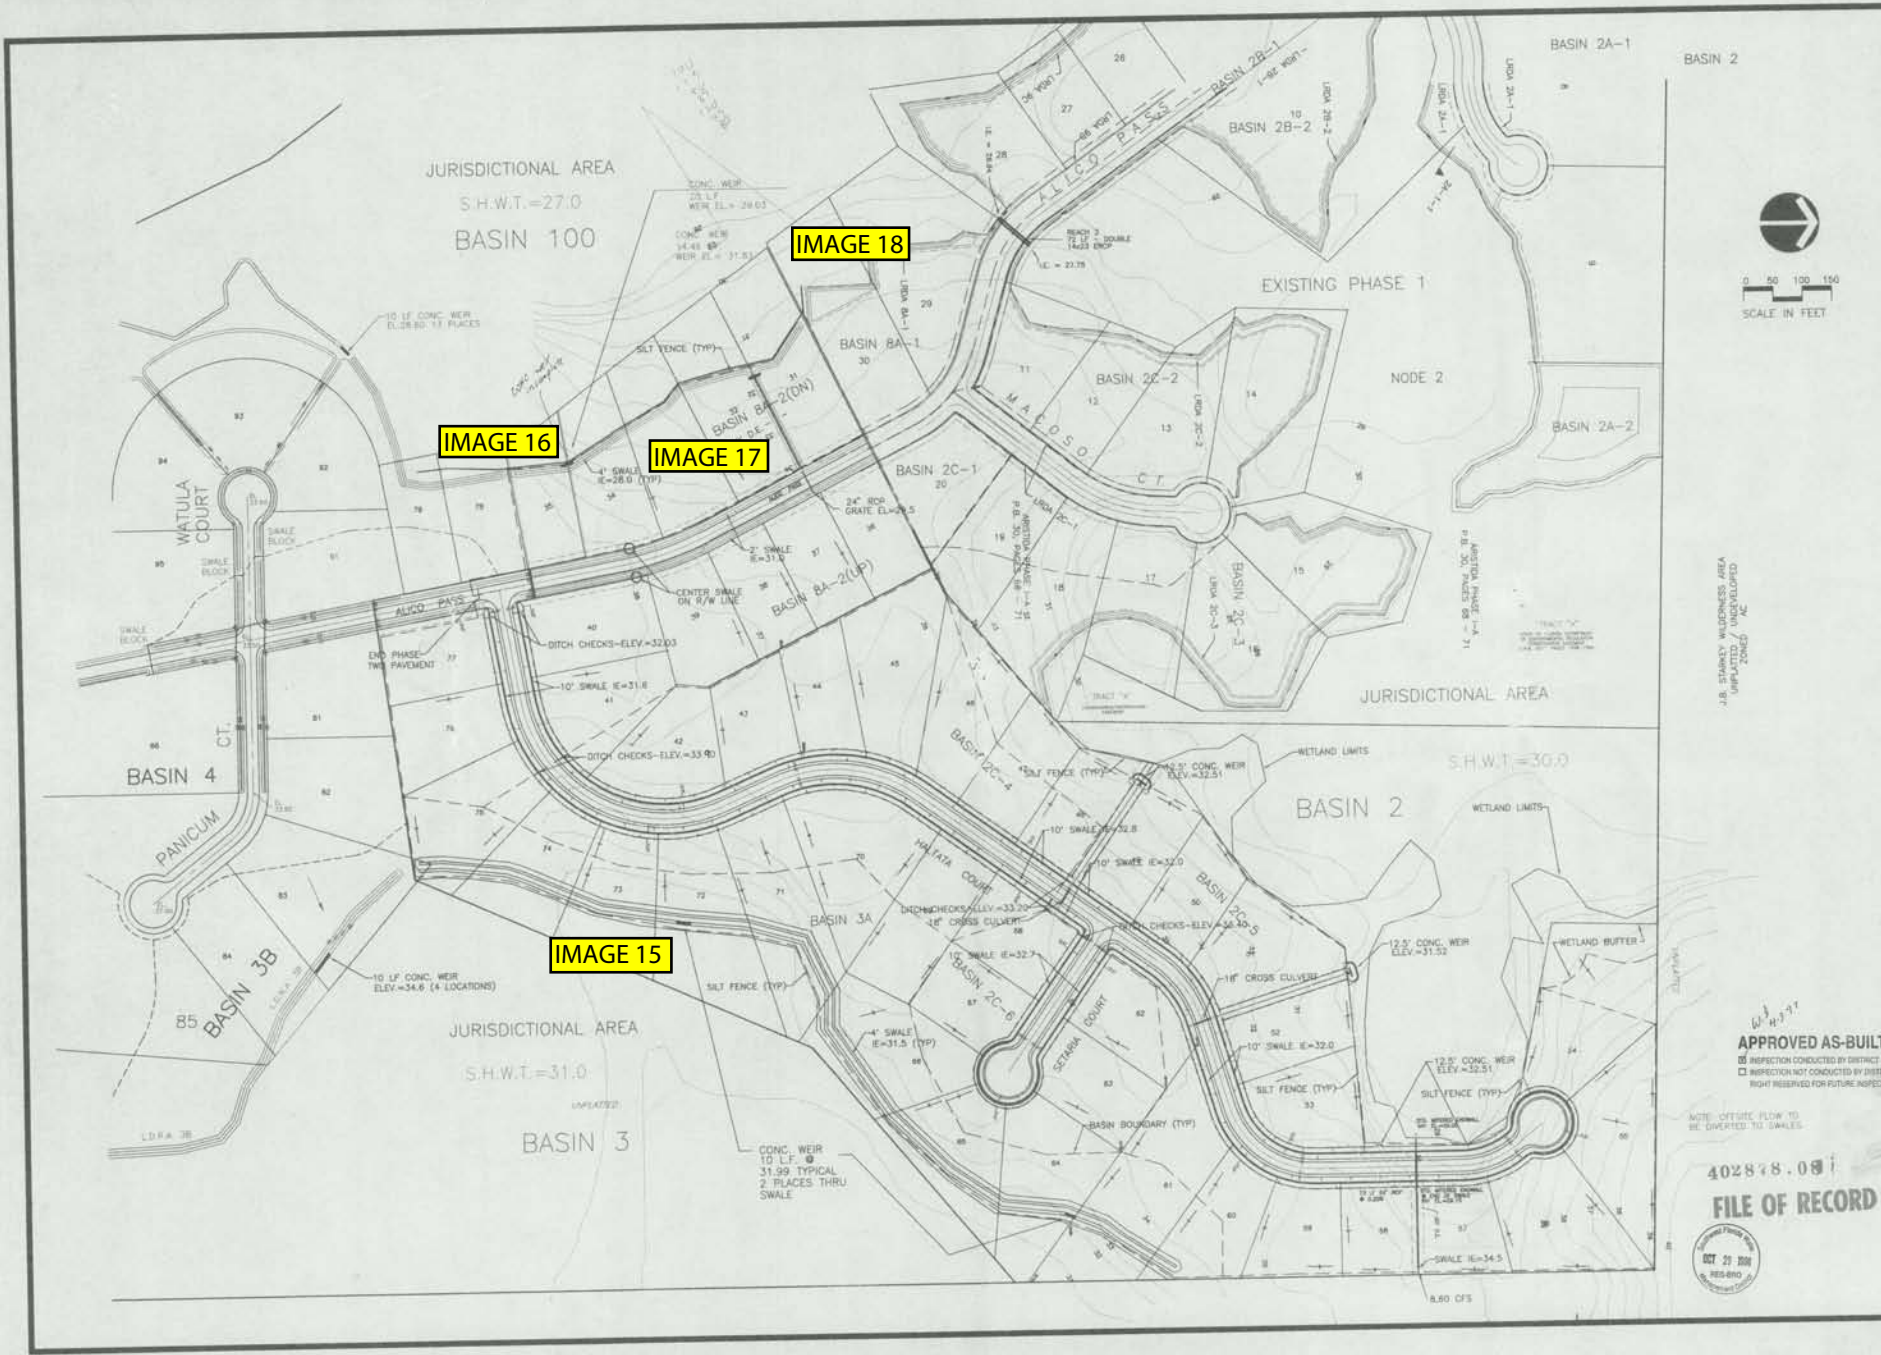
- There are also concrete Weir structures in the swale on the west side of the permitted area (behind the homes on Alico Pass) that discharge to the wetland that have excessive vegetation around the structures and inside the skimmers that should be cleared. Any silt build up under the skimmer should be removed. They may also require some re-trenching to ensure proper flow into the wetlands. (See images #16)

- At the time of our inspection there were some lawn areas that appeared to be damaged by feral hogs. One resident (5337 Haltata) complained about this to me while I was on site. She said they were getting through the fence of the adjoining conservation land that is under SWFWMD jurisdiction. She also mentioned that Michael May who is a board member was addressing the matter .(See images #9 & 18)

Image 16: Weir Structure, Skimmer west swale, needs clearing

Image 18: MES/Discharge, Feral hog damage
